1. AGENCY USE ONLY (LEAVE BLANK)	2. REPORT DATE 5 September 1995	3. REPORT TYPE AND DATES COVERED Professional Paper	
4. TITLE AND SUBTITLE  Developing Flight Test Techniques to Ensure Proper Rigging of Highly Augmented Aircraft		5. FUNDING NUMBERS  <b>19951107 055</b>

6. AUTHOR(S)  CAPT Ricardo Traven, CAF Susan E. Whitley		8. PERFORMING ORGANIZATION REPORT NUMBER

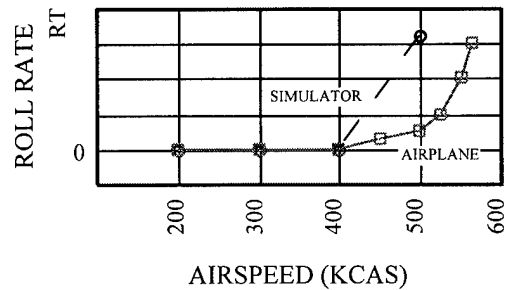
Figure 3  
CASE STUDY #1  
COMPARISON OF FLIGHT DATA TO  
SIMULATOR DATA

One NAWC-AD F/A-18A exhibited a strong tendency to roll to the right after take-off and required constant re-trimming in flight. A standard F/A-18 take-off is in configuration PA1/2. On this airplane, the roll rate in PA1/2 quickly rose to 3 deg/sec by 220 KCAS. Consequently, most pilots started trimming out the uncommanded roll immediately after take-off. When the configuration change to CR was made at approximately 200 KCAS, the uncommanded roll rate should have been zero; however, the trim input while in PA1/2 carried over into CR and trim in the opposite direction was required. Once trimmed for slow speed CR flight conditions, a high speed dash (above 450 KCAS) would result in an unacceptable amount of uncommanded right roll (15 deg/sec by 550 KCAS) that would require re-trimming. Pilots associated the constant requirement for trimming as behavior indicative of a "bent" airplane. When the NAWC-AD test team compared the in-flight data to the simulator data (figure 3), the LEF's were identified as the probable cause of the uncommanded roll rate.

An initial check of the LEF rigging confirmed that the LEF's were correctly rigged to the center of the reference rivet. The rigging of the LEF's was adjusted to counter the uncommanded roll rate. The left LEF was raised 0.04 inches to the top of the reference rivet and the right LEF was lowered 0.04 inches to the bottom of the reference rivet. These changes are within the published tolerance band for rigging the LEF's. The flight test results for the CR configuration before and after the re-rig are presented in figure 4. The uncommanded roll rate was reduced to less than 5 deg/sec at speeds up to 550 KCAS. NAWC-AD pilots now find the handling qualities of this F/A-18A acceptable for all flight profiles.

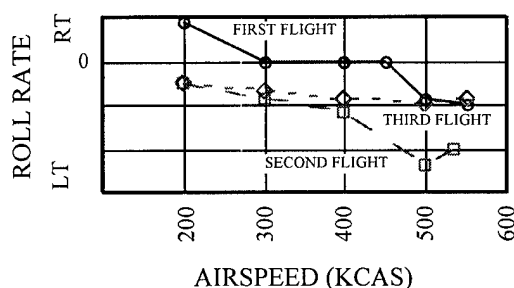
Figure 5  
CASE STUDY #2  
CR FLIGHT DATA

The airplane was flown prior to the first rigging to assess the handling qualities of the airplane and to quantify the complaints of the squadron pilots. The airplane exhibited a strong tendency to roll and yaw to the right above 25 deg AOA. By

35 deg AOA, the right roll and yaw rates were uncontrollable, as characterized by the NAWC-AD test pilot. Figure 5 presents the roll rate data and figure 6 presents the maneuvering flight data. The maneuvering flight data (figure 6) confirmed the squadron's most significant complaint, which was the inability to perform straight loops or any left rolling scissors maneuvers above 25 deg AOA and below 150 KCAS.

A second flight was flown on the airplane after a complete re-rig of the flight control surfaces. The results from this flight are presented in figure 5. While the CR roll rate trace shows a significant amount of roll

rate, the overall aircraft handling qualities were an improvement over those reported by the squadron's pilots. There was no maneuvering flight data collected on this flight; however, the NAWC-AD test pilot reported that although the yaw rate problem at high AOA was not ideal, it was tolerable. A comparison of the simulator data to the data from the second flight revealed that the probable cause was a TEF mis-rig in the mid-speed range and a LEF mis-rig in the high speed range. The NAWC-AD test pilot also noted that in flight the outboard LEF's were noticeably out of alignment with respect to the inboard LEF's, due to the effects of air loads on the LEF freeplay. The TEF's and the outboard LEF's were adjusted to correct the adverse handling qualities.

The data from the final flight are presented in figures 5 and 6. The roll rate in configurations PA and PA1/2 was reduced to insignificant levels ( $< 2$  deg/sec) and the highest roll rate observed in configuration CR was 5 deg/sec. This was considered acceptable by the NAWC-AD team. The yaw rate at high AOA during maneuvering flight was greatly reduced. The NAWC-AD test pilot was able to perform slow speed "over the top" maneuvers with no difficulty. Left rolling scissors, once impossible, were now easily flown at speeds below 150 KCAS and above 25 deg AOA.
